# 75 Wynford Heights Cres.

Toronto, Ontario • 2009

## Project Overview:

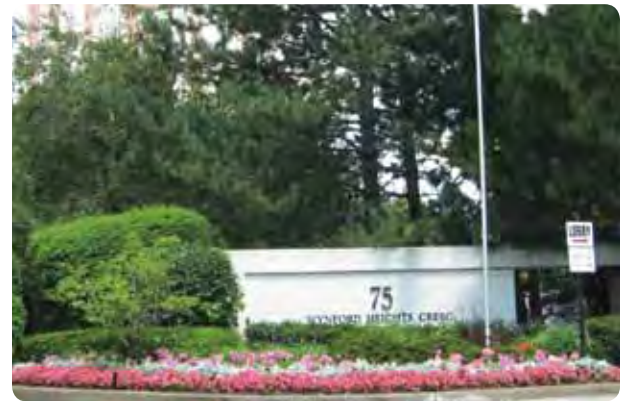
This investment in water conservation paid for itself in one irrigation season with **water savings of 76%.**
